# Manhole Inspection Summary

Manhole # S11WW1002MH

**Location** Address: **2415 KEN OAK RD**

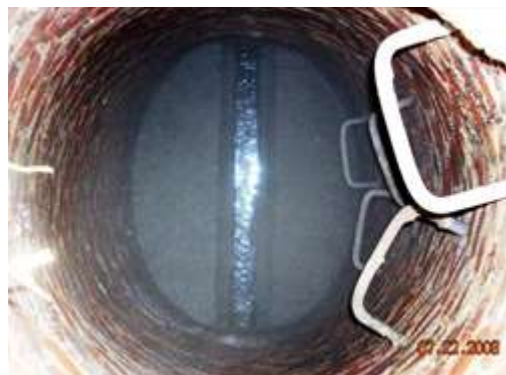
Top View

Corroded steps. Evidence of surcharge - Bench debris. Channel debris.

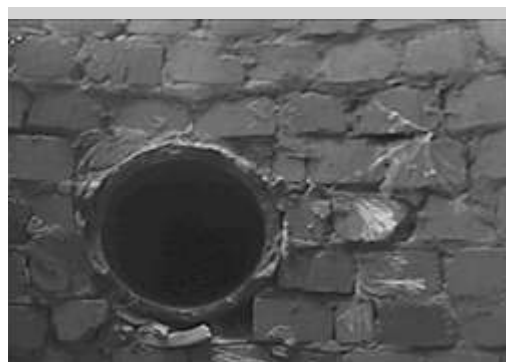
Storm sewer

Barrel deterioration, root intrusion and infiltration.

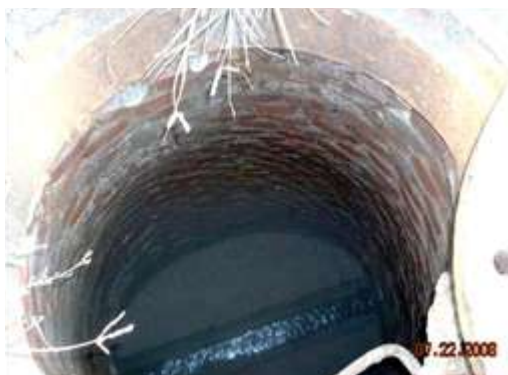
Defect

Frame leaks. Adjustment deterioration, loose brick and infiltration. Corbel and Barrel infiltration - other side.

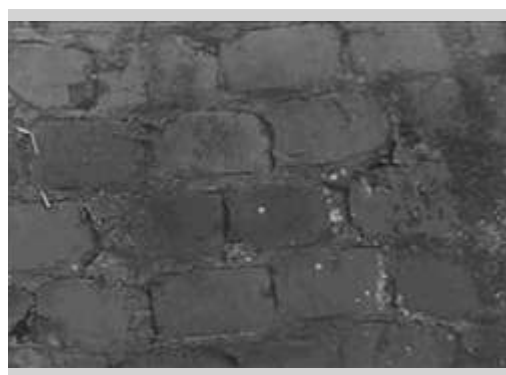
Defect

Corbel deterioration and infiltration.

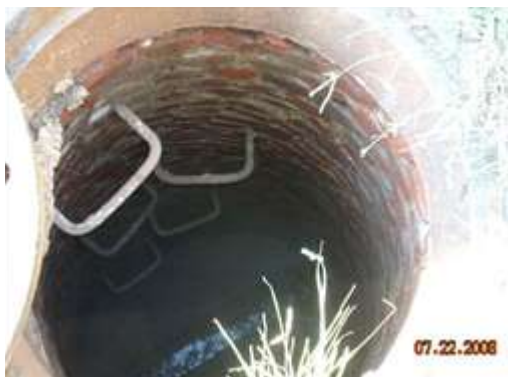
## Defect

Frame leaks. Adjustment deterioration, loose brick and infiltration. Corbel and Barrel infiltration.

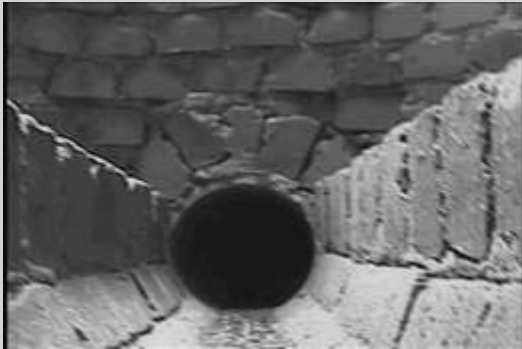
### 8 in. Circular Gravity Sewer Pipe Out @ 12 O'Clock

Barrel deterioration and infiltration. Channel deterioration.

Infiltration: **Evidence** Pipe Seal Cond: **Cracked**

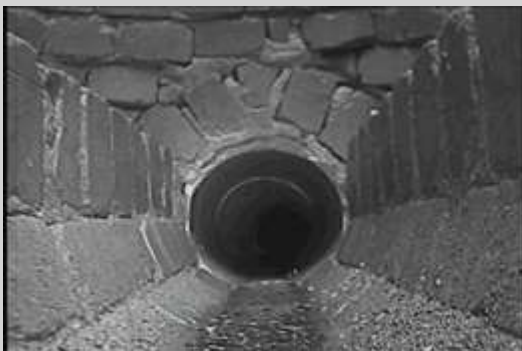
### 8 in. Circular Gravity Sewer Pipe In @ 6 O'Clock

Barrel deterioration and infiltration.

Infiltration: **Evidence** Pipe Seal Cond: **Cracked**
